Minnesota Power's Upgrade of Network Transformers

Daniel J Schultz, PE
Minnesota Power
30 W Superior Street
Duluth, MN 55802
218-355-2831 FAX 218-720-2795
dschultz@mnpower.com

On the evening of October 31, 2008, Transformer #1 at Minnesota Power's (MP's) YMCA Network Vault exploded violently and a huge fire ensued. This paper will provide a short description of network substations and will describe MP's restoration effort and actions to preclude a similar event in the future.

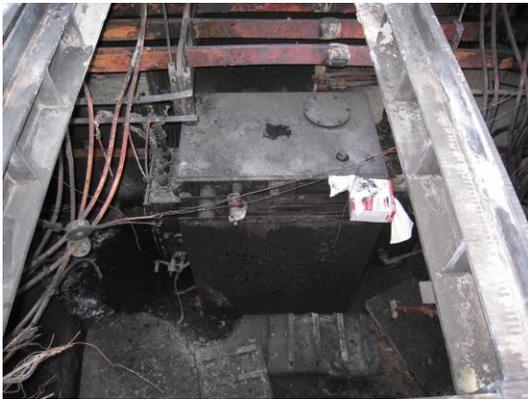
which blew open the heavy concrete hatch covers and destroyed the access ladder enclosure at the opposite end of the vault. In the ensuing fire, most of the primary and secondary cables inside the vault were destroyed. Even once the fire was put out, it was several hours before the transformer cooled enough to allow access to begin cleanup and repair. The other two transformers were not damaged by the fire. Although the YMCA did not have a standby generator and the pool overflowed without the backup, the two large communication facilities which are served at this location had backup generation so their outages were minimal. Once MP crews were able to access the vault, the burned off primary and secondary cables were spliced and the busbar sections over the burned out transformer were removed. The failed transformer was removed and hauled to the Herbert Service Center for evaluation. The remaining transformers were placed back into service on late Sunday, November 2.

The picture below on the left shows the failed #1 transformer with burned out wiring and some of the hatch covers lying in the bottom of the vault. The picture on the right shows the collapsed walls for the ladderway at the opposite ends of the vault. The double layer of gypsum board was replaced with ¾" fire resistant plywood.

Although the remaining two transformers in the YMCA vault were adequate to carry the load on this network, it was decided to proceed with rebuilding the failed transformer on a priority basis because of the age of the remaining transformers and the fact that combustible gas analyses of these units were above normal. Jordan Transformer was selected for this work. The transformer would be rewound and the primary switch would be replaced with a Quality (brand) switch. Cooper FR3 non combustible fluid was

chosen to eliminate future explosion risk. It is interesting to note that in spite of the fire and explosion, the original winding passed TTR and Megohm tests and could have been placed back into service. The repaired transformer was received in December, 2009, approximately a year after the fire. The rewound transformer was re-energized on November 1, 2010, including a new primary control switch to be discussed later. The transformer was placed in service after an overnight outage to connect the secondary conductors on November 17, 2010.

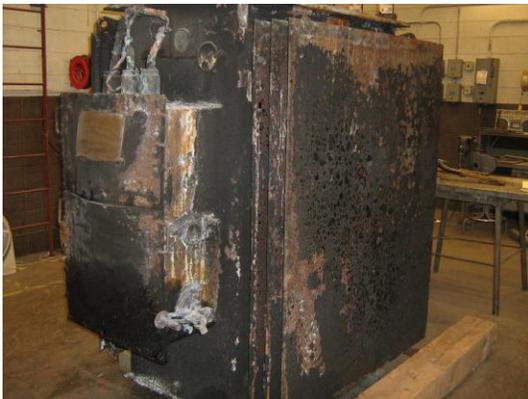
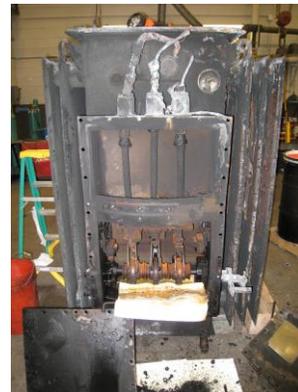
The pictures below show transformer #1 after it was removed to the shop and the opened primary switch compartment.

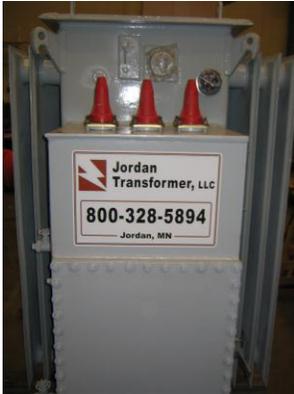
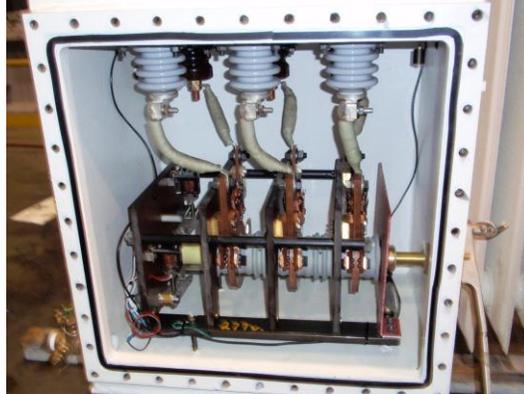
The pictures below show the rewound transformer as received and the new primary switch before it was closed and filled with oil at Jordan Transformer.

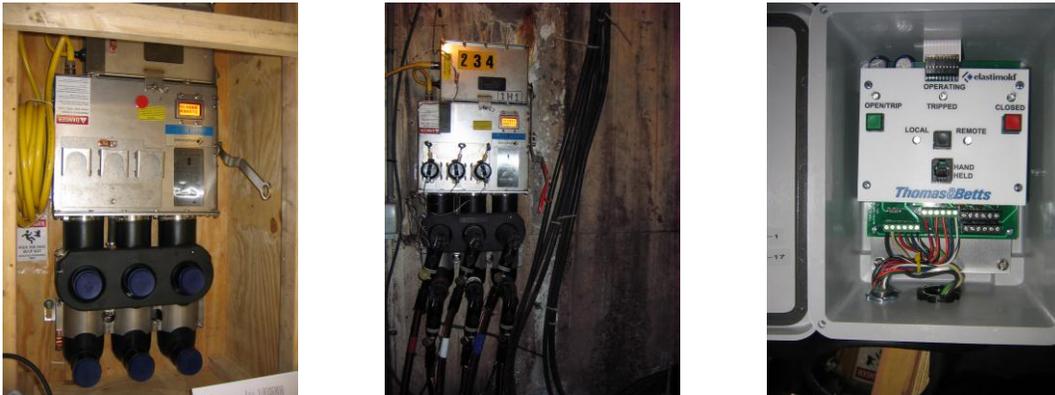
The picture below on the left shows the MVI switch as received. The center picture shows it installed on the wall of the network vault adjacent to Transformer #1. The picture on the right shows the motor control box for the switch. The yellow cable leaving the MVI on the top left connects to the control box.

As noted above, the failed transformer was rewound and rebuilt to include the usual primary switch. In October, 2009, an order was placed for a single MVI switch for testing and evaluation. It was to be mounted on the wall in the YMCA vault adjacent to the rebuilt transformer #1. The first switch arrived in December. In January, we energized it with 120 VAC control power and were able to test operate the switch. However, we found that we didn't order the required computer interface cable to program the unit, so programming was delayed until the cable was received. Once we received the cable, we were successful in accessing and programming the overcurrent setpoints in March.

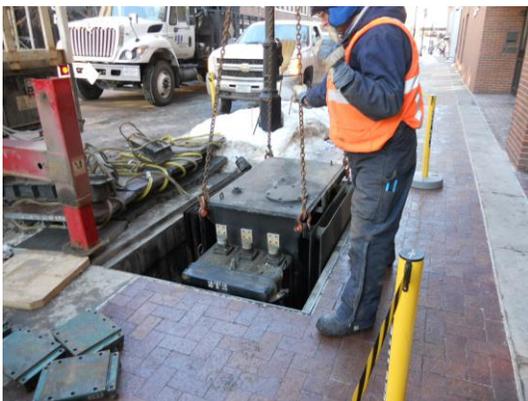
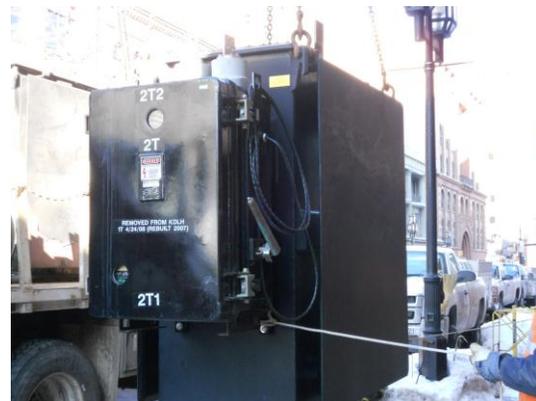
Although it is not a simple task to remove concrete hatch covers and raise and lower transformers weighing 10,000 to 14,000 pounds thru an opening just big enough to squeeze the transformers thru, the substation Construction and Maintenance crew handled the project comfortably. The pictures below show the old Transformer #2 being lifted out and the new Transformer #2 being lowered into the vault. Note that the network protectors are attached.

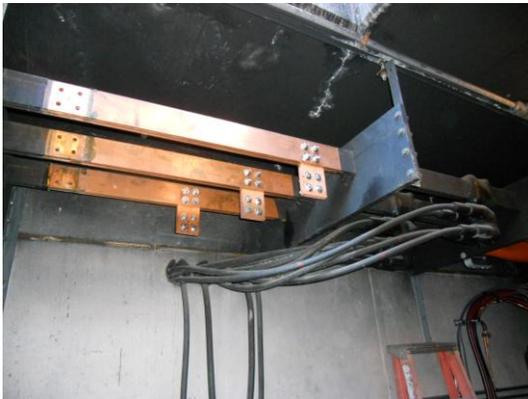
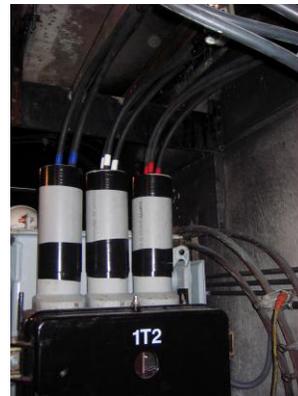
The pictures below show the busbar extensions for Transformer #2 and the completed connections on Transformer 1. Note that the current limiting fuses are enclosed in the PVC tube above the network protector.

The largest single problem that we encountered was the connection of the 480 Volt secondary conductors. We explored catalogs and checked on line but were not able to find a compact 480 volt rated switch capable of carrying 1200 to 1800 Amperes. The three phase busbars were spaced approximately 10" apart and were each composed of two or three 1/4" by 4" copper bars. Even if cover-up were to be installed on the busbars, it was felt that it would be too hazardous to connect the 500 MCM copper jumpers onto the busbars while they were energized. In an effort to separate the individual phase conductors from each other, three sets of 1/4" by 4" busbar, 8" long were designed to be installed below the existing busbars to provide staggered 4" by 4" "paddles" underneath the bus to attach the cables. In

spite of this minor accommodation, it was necessary to plan a total power outage in the vault to connect the secondary conductors.
