# Improving System Protection Reliability and Security

Steve Turner  
Beckwith Electric  
STurner@BeckwithElectric.com

This paper is based upon a NERC report released in 2013 that claimed a dramatic rise in the annual number of misoperations—due in large part to the complexity of programming and testing numerical protection relays. This paper illustrates results discussed in the NERC report, as well as provides several interesting examples of actual misoperations and how to mitigate them.

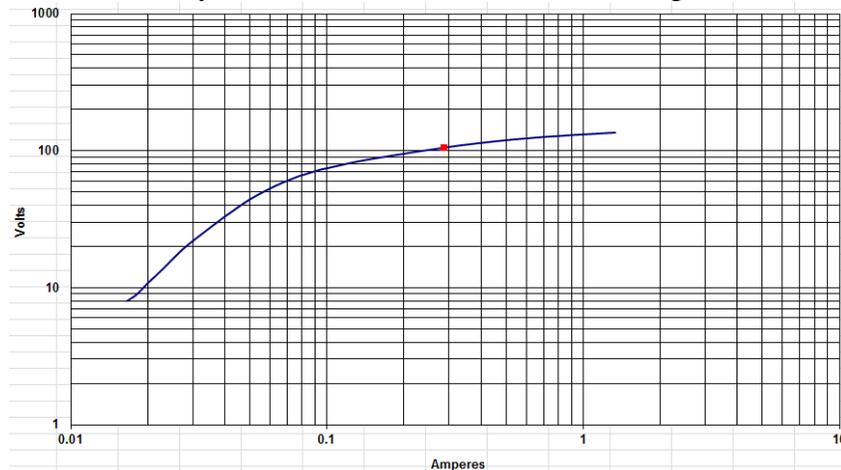
Review of the relay settings revealed the relay that did not trip had a higher pickup setting by a factor greater than four times. The CTs have a knee point of 100 volts or less which is low and there was the presence of heavy dc offset in the C-Phase current (Figure 3).

**Figure 3. C Phase Neutral Side CT Excitation Characteristic**

Higher C class CTs can help to mitigate saturation (Figure 8).

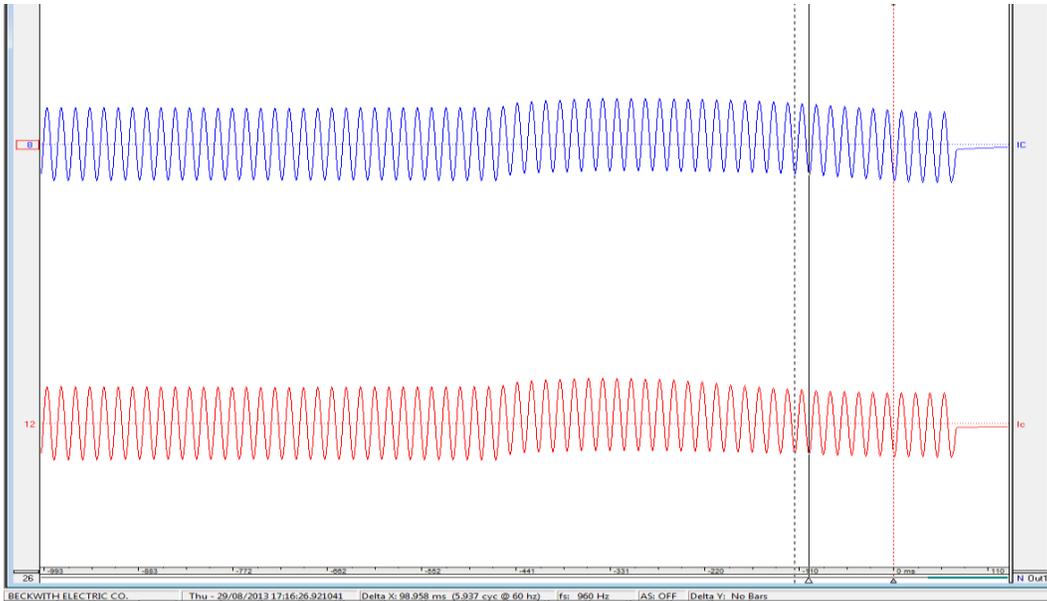
Figures 4A and 4B show the high levels of dc offset present in C-Phase current during the event. DC offset current is the number one cause of CT saturation.

**Figure 4A. Generator C-Phase Current**

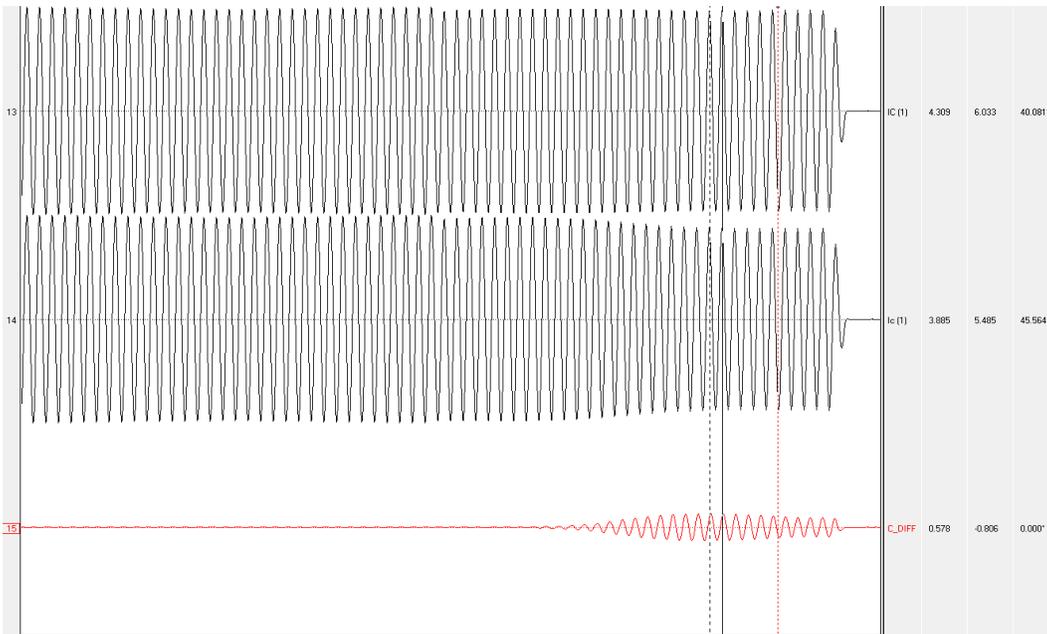
**Figure 4B. Generator C-Phase Differential Current**

**Best Practice:** If the DC offset from transformer inrush (e.g., black start) or fault condition can cause CT saturation, then the following are appropriate for generator phase differential protection settings:

- Minimum pickup up to 0.5 amps secondary
- Slope of 20 percent
- Time delay up to 5 – 8 cycles

Detailed calculations are necessary for generator differential protection to determine if CTs can saturate; do not simply copy settings from the relay instruction book without actual verification.

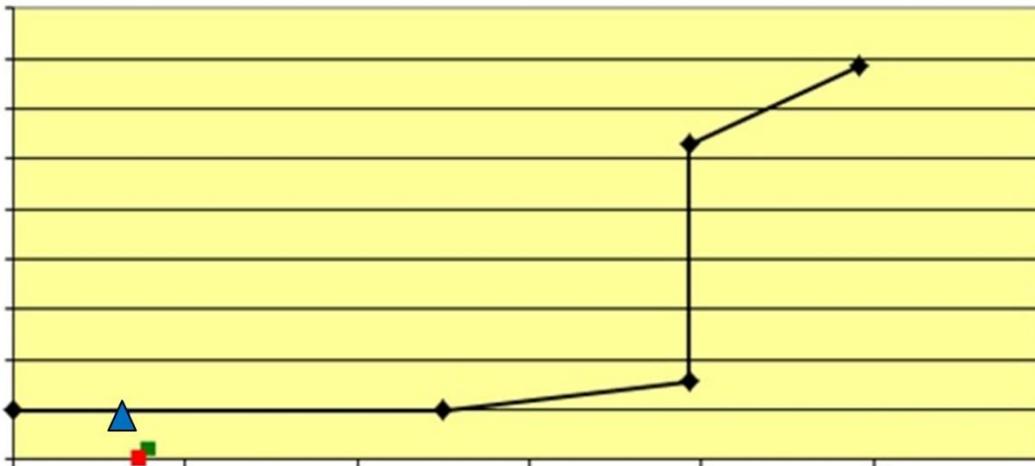
The blue triangle in Figure 6 corresponds to the C-Phase operating point which was just on the boundary of operation. The misoperation occurred when the current was coming out of saturation.

**Figure 6. 87 Phase Differential Operating Characteristic**

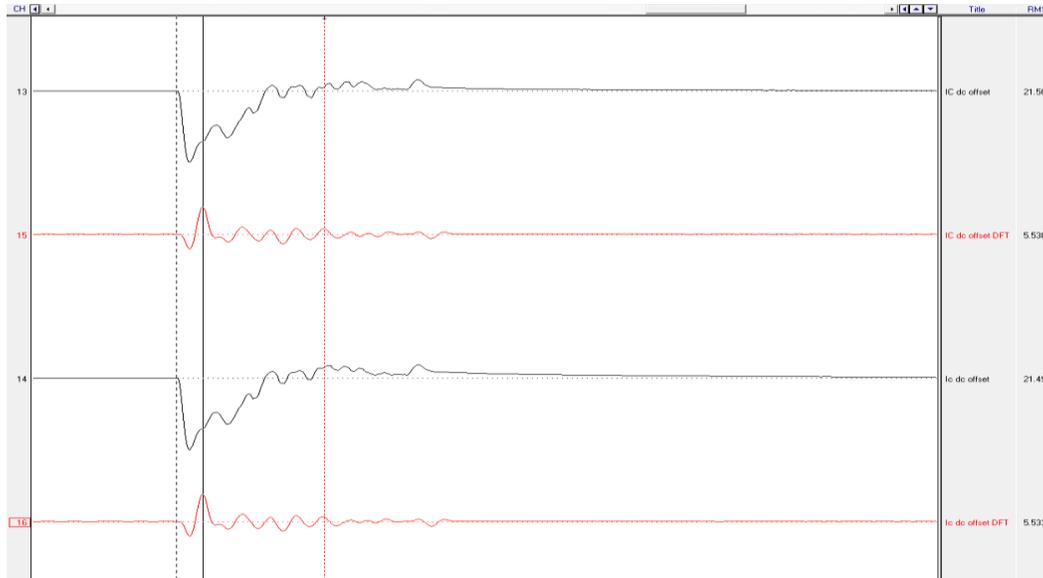
The DC offset present in fault current exponentially decays as shown in Figure 7. The digital Fourier transform algorithm cannot fully reject it.

**Figure 7. DC Offset Current**

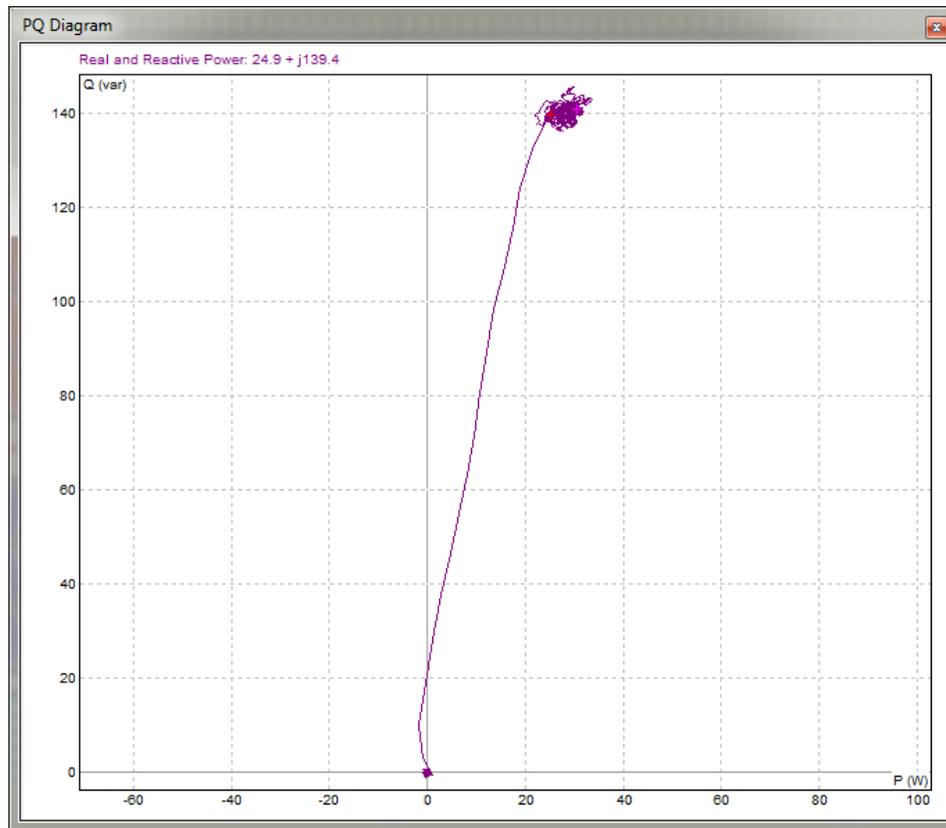
A utility experienced several misoperations when system voltage was low. However, the trip shown in Figure 9 occurred when the machine was under excited and drawing vars from system.

**Figure 9. Machine Real and Reactive Power at time of 27TN Trip**

The solution for this particular machine is to block on low forward power as this is the prevailing system condition when the nuisance trip occurs. The main drawback to this solution is there is no protection for stator ground faults close to neutral during this operating condition.

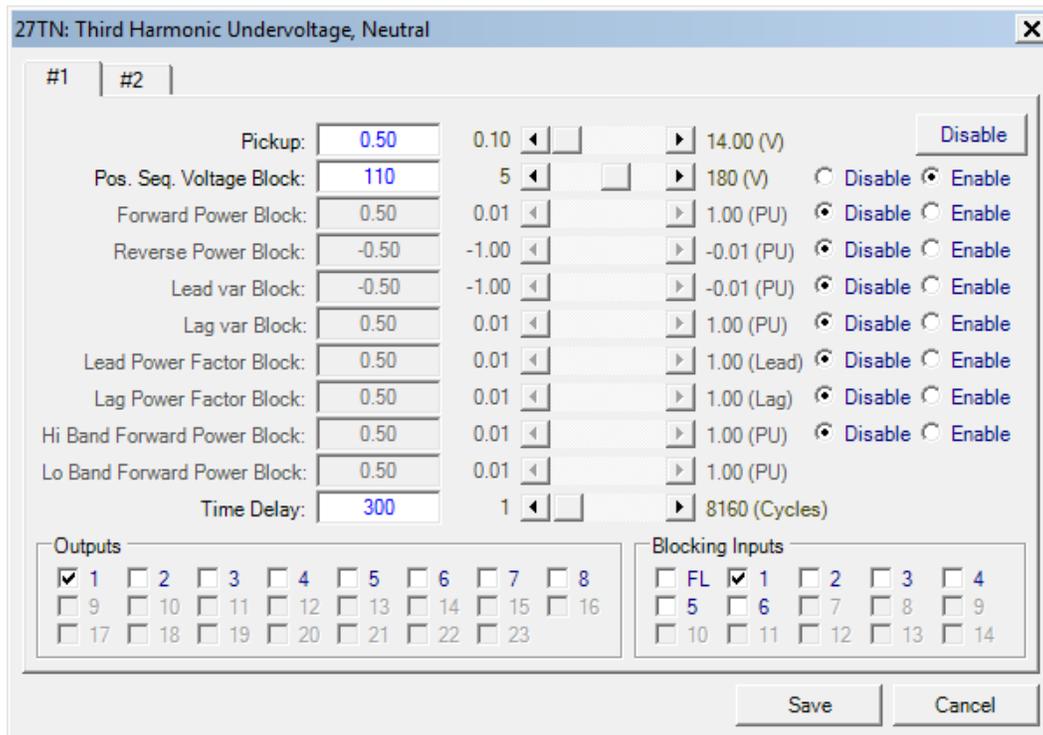
Third harmonic neutral voltage changes as a function of load. The pickup setting is typically set equal to one-half of the minimum value measured during normal operation. Figure 11 illustrates how complex it can be to securely set 27TN protection by use of the blocking functions.

**Figure 11. 27TN Settings**

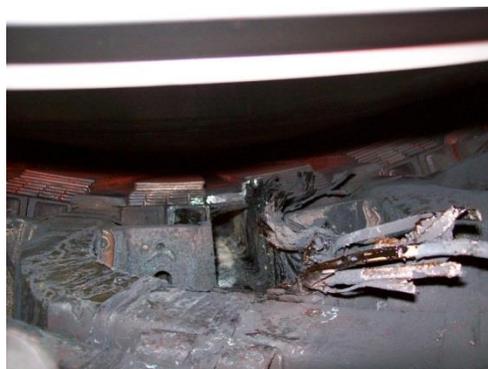
There has been recent experience with four such failures in large generators that demonstrate lack of proper protection can be disastrous. Each of four failures caused massive damage to generator and collectively had total cost, including repair and loss of generation, close to \$500,000,000. This demonstrates that the failure of stator windings in the last five percent of the winding is not uncommon. See Figures 13A, 13B and 13C.

**Figure 13A. Winding Damage - Broken Stator Winding Conductor**

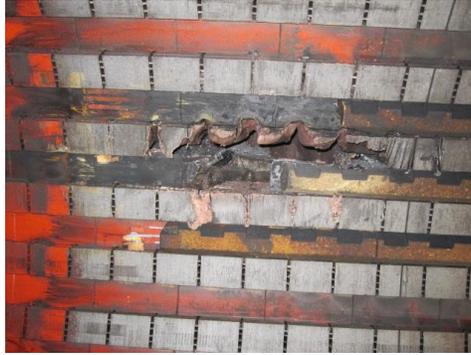
**Figure 13B. Core and Winding Damage - Burned Open Bar in a Slot**

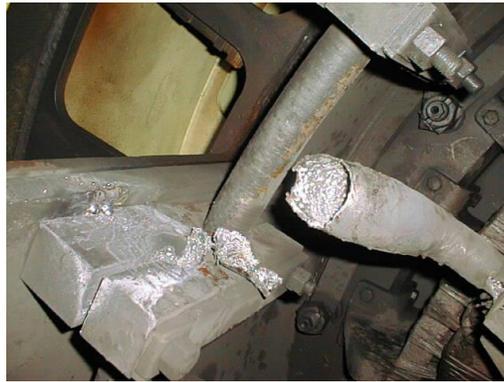
**Figure 13C. Burned Away Copper - Fractured Connection Ring**

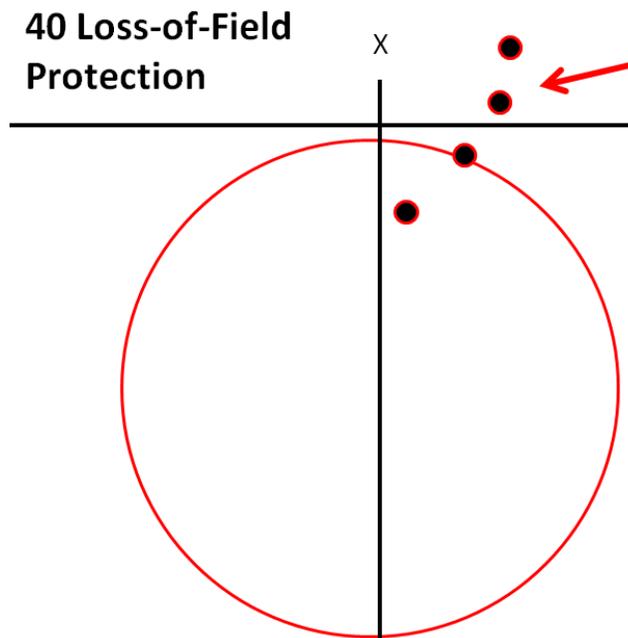
Two customers experienced generator protection misoperations due to incorrect phase rotation settings. The first misoperation was 40 loss-of-field protection (Figure 16).

**Figure 16. 40 Loss-of-Field Protection**

- 40 operates on  $Z_1$  (positive-sequence impedance)
- 40 measures incorrect impedance due to wrong phase rotation setting
- 40 trips each time customer attempts to synch the generator to the grid

How did either incorrect relay setting make it past commissioning? Both elements (40 and 78) were effectively operating on  $Z_2$  (negative-sequence impedance) due to the incorrect phase rotation settings.

**Best Practice:** Modern numerical relays have built-in tools provided to determine the actual phase rotation. Phase rotation can quickly be checked using numerical relay metering.

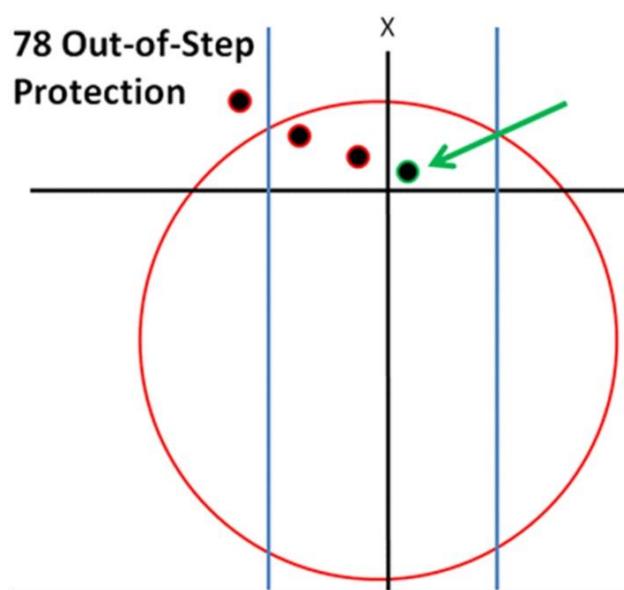
The second misoperation was 78 out-of-step protection (Figure 17).

**Figure 17. 78 Out-of-Step Protection**

- 78 operates on  $Z_1$  (positive-sequence impedance)
- 78 measures incorrect impedance due to wrong phase rotation setting
- 78 tripped during external event
