# **Minnesota Power's Boswell Unit 3 Environmental Compliance and Electrical Infrastructure Upgrades**

## **Abstract**

To meet government mandates for emissions, Boswell Energy Center Unit 3 was retrofitted with emission controls from 2006-2009. As part of this project, the entire auxiliary medium voltage electrical infrastructure was replaced due to capacity and interrupting capability issues. The overall goals of the project were to meet emission requirements while creating an operationally safer electrical infrastructure and maintaining unit net power production. The combined Unit 3 projects consisted of the environmental retrofit, turbine efficiency upgrades, dry ash handling, and duty cycle preservation projects which included the electrical infrastructure upgrades. The execution of these projects was a multiple discipline engineering effort, and the overall investment in Boswell Unit 3 as a result of these projects was approximately \$300 million.

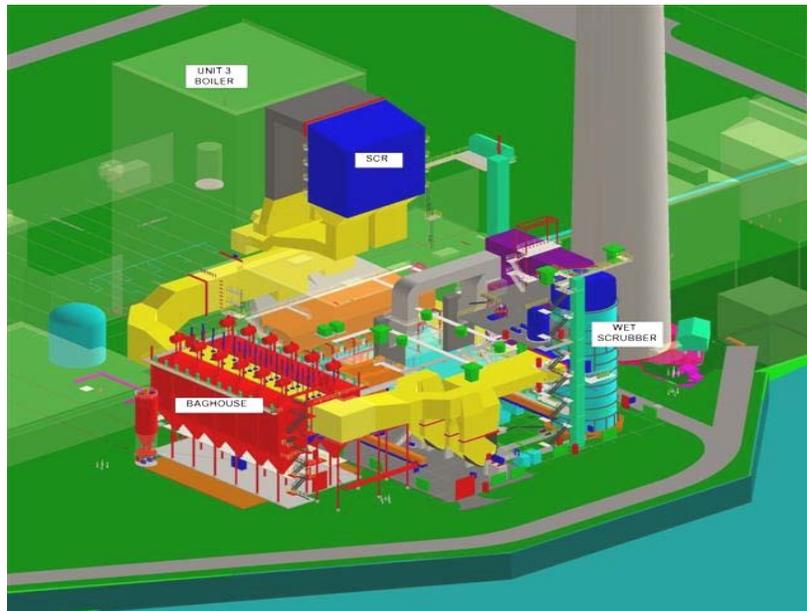
*Figure 1 – 3D Model of the Unit 3 Emissions Control Equipment.*

- Low NO<sub>x</sub> burners and an overfire air system for NO<sub>x</sub> control
- Selective Catalytic Reduction (SCR) system for NO<sub>x</sub> control
- Wet Flue Gas Desulfurization (FGD) system for SO<sub>2</sub> control
- Fabric filter baghouse for particulate matter and mercury control
- Activated carbon injection system for mercury control
- Induced Draft (ID) fans, motors, and variable frequency drives

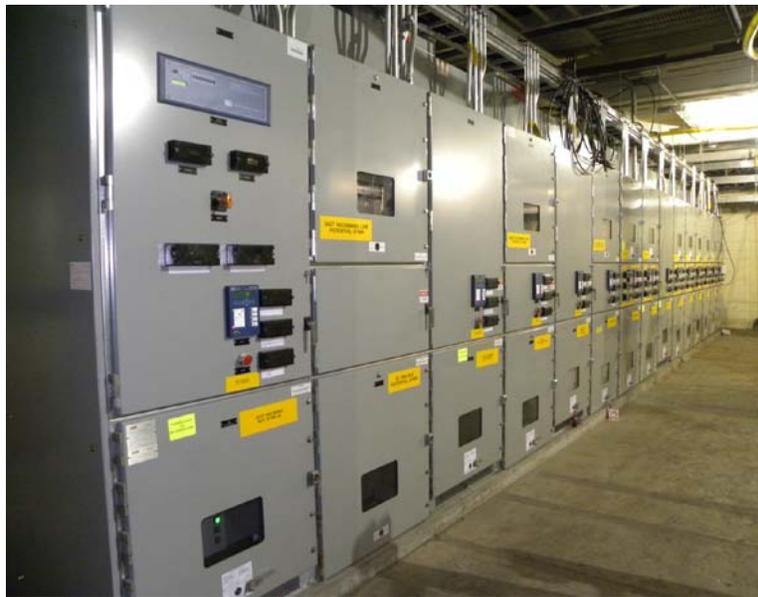
*Figure 4 –New Arc Resistant 4.16kV Bus 3A*

For the Boswell Unit 3 project, arc resistant switchgear Type 2BC was chosen to provide maximum protection for personnel that may be working at the front, back, sides or in the low-voltage compartment of the switchgear. The C suffix option was selected to provide a degree of compartment-to-compartment protection and to minimize damage to adjacent switchgear sections in the event of an arc fault. Due to space constraints and the need for two-high breaker cubicles, an exception was made to the 2BC designation in the rear cable compartment which was designated as Type 2B only.

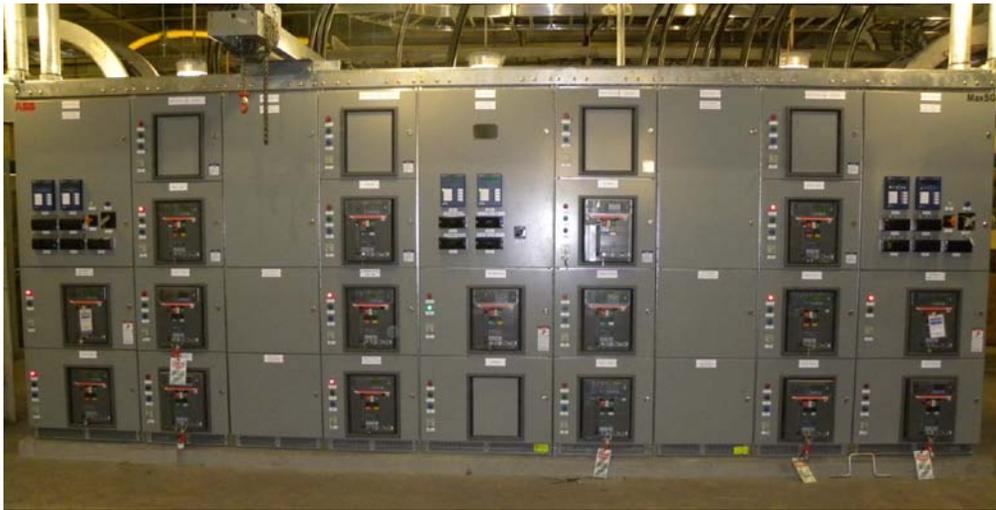
*Figure 8 –New 480V Metal-Enclosed Switchgear*

Standard metal-enclosed low voltage switchgear was selected for the project using draw-out power circuit breakers with integral electronic trip units. Like the medium voltage equipment, the goal for low voltage electrical equipment on the project was an incident energy rating equal to or less than  $8 \text{ cal/cm}^2$  (NFPA 70E Hazard/Risk Category 2). Given the high level of available fault current at the 480V system level, and the relatively long main breaker clearing time for a bus fault, arc flash mitigation methods were required to meet this incident energy goal.

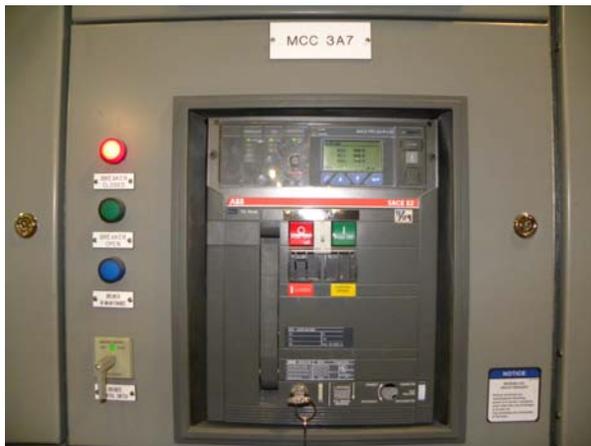
*Figure 9 – 480V Feeder Breaker*

The second arc flash mitigation method used for the low voltage switchgear was a switch and status light that plant personnel could use to enable an instantaneous protection element while performing maintenance on the equipment. This “maintenance mode” option was provided on both the main and feeder breakers. On the main breakers, the scheme used a contact from a switch located on the main breaker to enable a second settings group in the electronic trip unit that included an instantaneous element. An output from the trip unit initiated a blinking blue light on the main breaker door to positively alert maintenance personnel that the breaker is in maintenance mode, while an additional output contact from the trip unit was used to alert plant control room operators that maintenance was being performed on the bus and that normal relay coordination on the bus had been compromised. On the feeder breakers, the scheme used a contact from a switch mounted on the equipment being fed (motor control center, power panel, etc.) to enable the second settings group in the electronic trip unit. An output from the trip unit initiated a blinking blue light on the remote equipment to positively alert maintenance personnel that the breaker is in maintenance mode. As with the main breaker, an additional output contact from the trip unit was used to alert plant operators. For both the main and feeder breaker it is important that the schemes be designed as fail safe so that the electronic trip unit reverted to “maintenance mode” anytime the signal between the maintenance switch and the trip unit was lost.

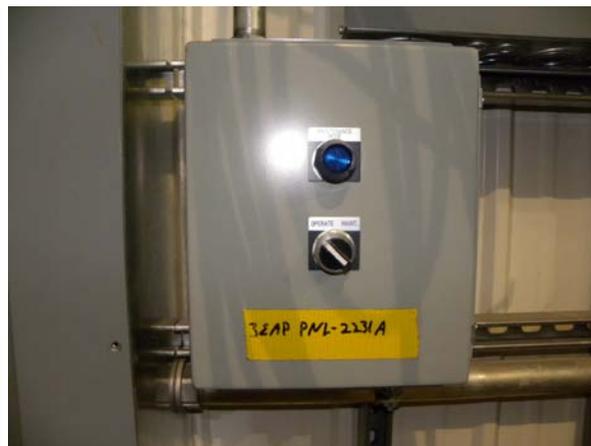
*Figure 10 – Maintenance Switch at 480V Panel*
