STRAY FLUX AND ITS INFLUENCE ON PROTECTIVE RELAYS

Abstract

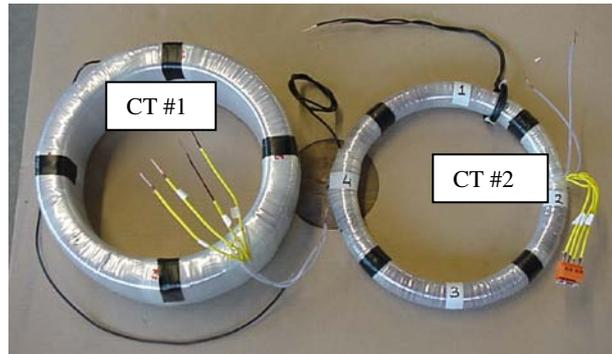
Figure 2 : Tested CT cores in the Laboratory [3].

The laboratory testing was performed on the two CT cores designated CT #1 and CT #2 as shown in Figure 2.

Both CT cores have the ratio 800/1A with a relative small core cross section. The only important difference between the two CT cores is the core cross section area. The core cross section area of the CT #1 is 17.1cm^2 and the core cross section area of the CT #2 is 1.9cm^2.

Note that on both CT cores, shown in Figure 2, an additional secondary flux equalizing winding is already wound. This flux equalizing winding is divided in four equal sections, evenly distributed around the core circumference (see black markings on the two CTs in Figure 2). Note that its influence can be enabled or disabled by changing externally available connections of the four segments ends. Thus presented results from the laboratory testing were shown with disabled flux equalizing winding influence.

When the laboratory testing of CT #2 (see Figure 2) was repeated with the flux compensation winding enabled by connecting its four segments in accordance with the second solution shown in Figure 12b, no secondary current spikes were observed when current was injected through the primary conductor adjacent to the CT core (see Figure 4).

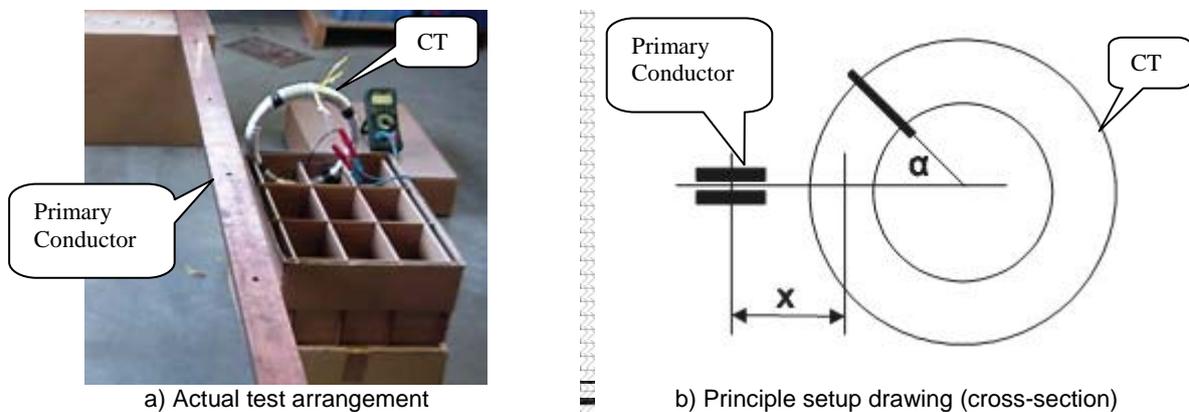
Figure 3 : Laboratory test setup [3].

As shown in Figure 3, the stray flux influence is tested by positioning the CT core close to an adjacent primary conductor. Figure 3a was taken by digital camera during laboratory testing, while Figure 3b represents the simplified geometrical view of the test setup. The distance X is 6cm during these tests. The test was done by applying the 50Hz, AC current with the RMS value of 6.5kA. The primary current could be injected with or without a DC offset. The applied current through the primary conductor and the CT secondary current were recorded by an oscilloscope as Channel 1 and Channel 2 respectively. These two waveforms are given in Figure 4 [3]. In the Figure 4a, the two waveforms are given when the DC offset is present in the primary current. The CT secondary current with maximum peak of 1.5A was recorded during this test. In Figure 4b, the two waveforms are given for the symmetrical primary current with AC RMS magnitude of 6.5kA. The recorded peak of the CT secondary current during this test reaches 0.2A. Note that secondary current spikes are only observed during testing of CT #2 and not during testing of CT #1.

a) Actual test arrangement

b) Principle setup drawing (cross-section)

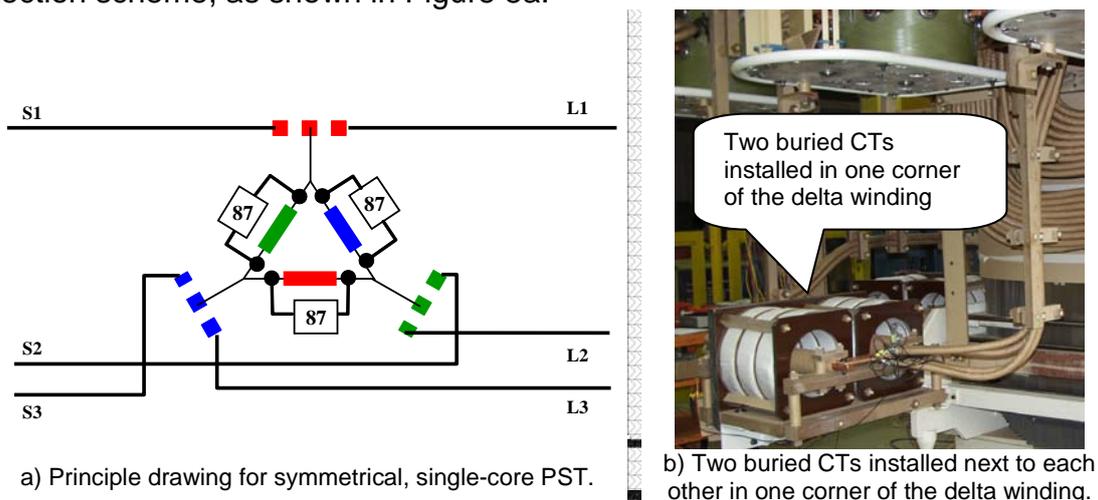
Figure 5 : Application information for the first field case.

a) Principle drawing for symmetrical, single-core PST.   b) Two buried CTs installed next to each other in one corner of the delta winding.

The two recorded currents should have the same waveforms with opposite polarity (e.g. their sum shall be zero). However, it is clear that one of the two currents (i.e. red trace in Figure 6) is distorted for a part of the power system cycle. Actually, its peak

value is almost completely reversed. Later it was concluded that this waveform distortion was caused by stray flux from the primary current in the neighboring phase (see Figure 5b).

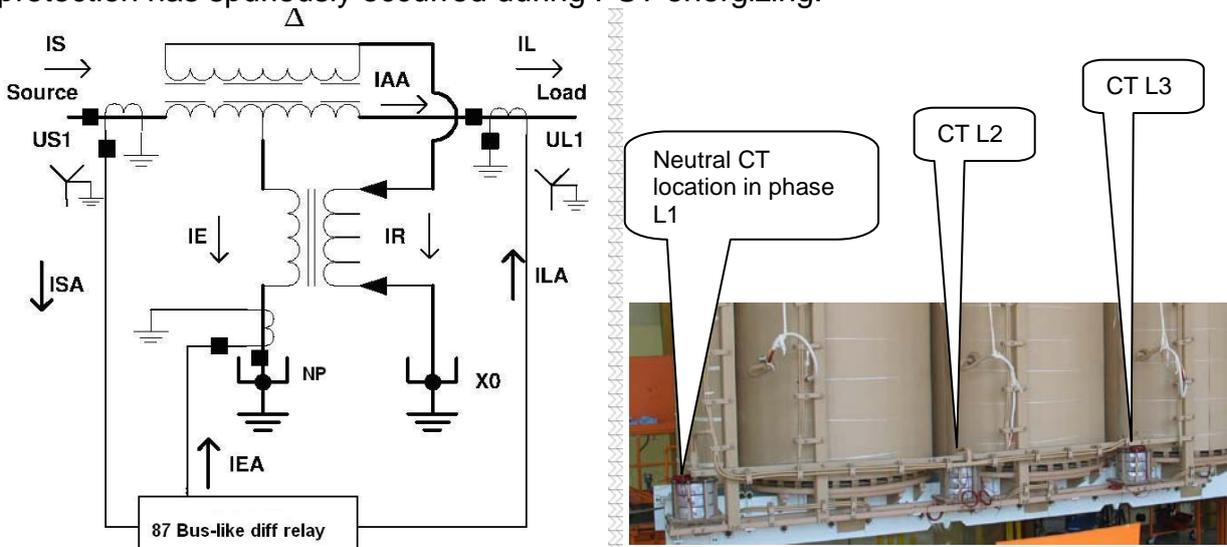
Figure 7 : Application information for the second field case.

Within a symmetrical, dual-core PST [6] with rating data 600MVA, 232/232kV, ±35°, 50Hz, buried CTs (with rated data 1200/1A; 10P20; 60VA) are installed. CTs are located at the neutral point of the PST primary exciter winding in each phase, in accordance with main differential protection scheme recommended [5] and shown in Figure 7a. Due to space limitations within the tank, neutral point CTs used for this differential protection are located next to the yoke of the magnetic core of the excitation transformer (see Figure 7b). Unwanted operation of the differential protection has spuriously occurred during PST energizing.

a) Principle drawing for symmetrical, dual-core PST.

b) Buried CTs installed close to the transformer yoke.

The current waveforms in phase L1, captured by the built-in disturbance recorder within differential relay, during one PST inrush case, are shown in Figure 8a. Because the Load-side circuit breaker was open during PST energizing, the two recorded currents should have the same waveforms with opposite polarity (e.g. their sum shall be zero). However, it is clear that the neutral point current is distorted for a part of the power system cycle. Actually, its peak value is reversed. Later it was concluded that this waveform distortion was caused by stray flux coming from the PST excitation transformer.

Several unwanted operations of the differential relay were recorded. During an another inrush cases the distorted CT current reached more than 25A secondary in peak current value in phase L3, as shown in Figure 8b. Such big current caused unwanted operation even of the unrestrained differential protection element.

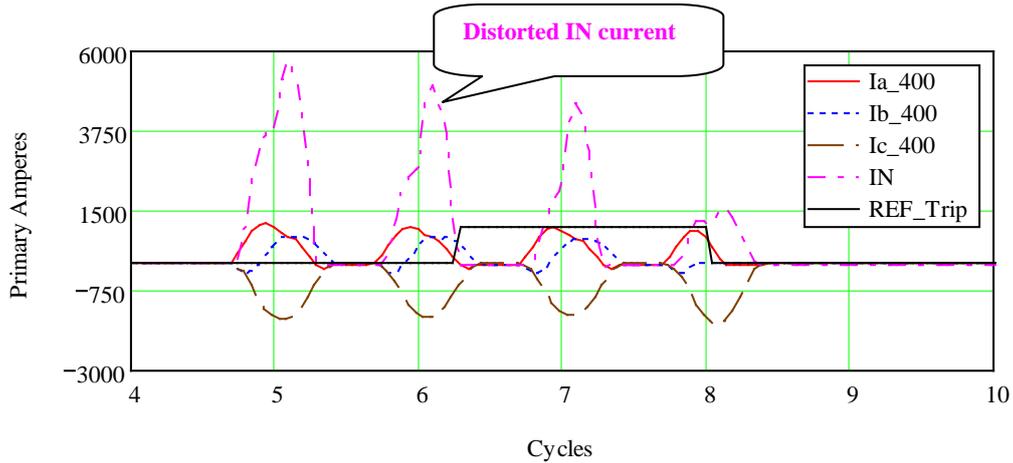
Figure 9 : Recorded currents during auto-transformer energizing from 400kV side.

Within an auto-transformer with rating data 500MVA, 400/132kV, 50Hz [5] common neutral point CT (with ratio 2400/1A) is installed within the tank. Several unwanted operations of the low impedance restricted earth-fault (REF) relay were recorded. Figure 9 shows one of captured inrushes when low impedance REF relay operated. From the recording it is clear that auto-transformer neutral point current is distorted. Its peaks are much bigger then corresponding 3Io current at 400kV side. This neutral point current distortion is caused by the stray flux from the auto-transformer main magnetic core.

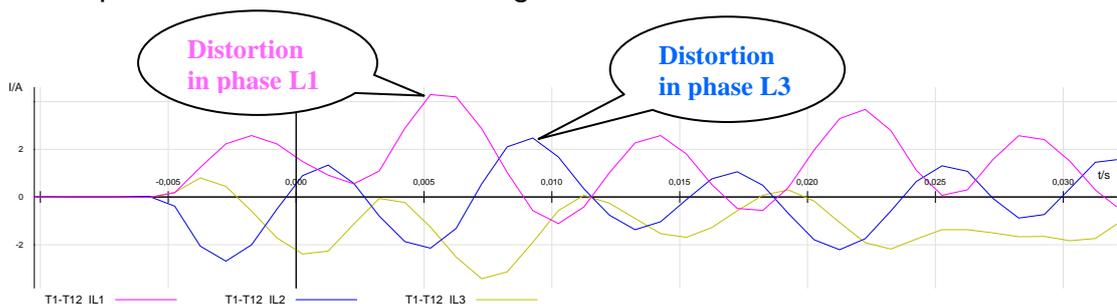
Figure 10 : Recorded secondary currents from the transformer LV CTs during SVC energizing

Within a SVC transformer with rating data 100MVA, 220/19kV, YNd11, 50Hz [5]; LV side CTs (with ratio 6000/1A) are installed as bushing CTs. However due to space limitations they were physically installed just under the LV bushings within the transformer tank. Several unwanted operations of the high impedance bus differential protection relay for the 19kV SVC bus were recorded during SVC energizing (i.e. SVC transformer together with SVC filter branches on the LV side were energized) from the 220kV side. Figure 10 shows recorded transformer LV side currents while the Figure 11 shows recorded resultant differential currents seen by the numerical high impedance bus differential relay during one such incident. Note that the high impedance differential relay stabilizing resistor had value of 1500Ω and that the relay pickup was set at 130V.

Investigation has shown that these unwanted operations were caused by the stray flux from the power transformer core during inrush conditions.
