# Improving System Protection Reliability and Security

Steve Turner  
Beckwith Electric  
STurner@BeckwithElectric.com

This paper is based upon a NERC report released in 2013 that claimed a dramatic rise in the annual number of misoperations—due in large part to the complexity of programming and testing numerical protection relays. This paper illustrates results discussed in the NERC report, as well as provides several interesting examples of actual misoperations and how to mitigate them.

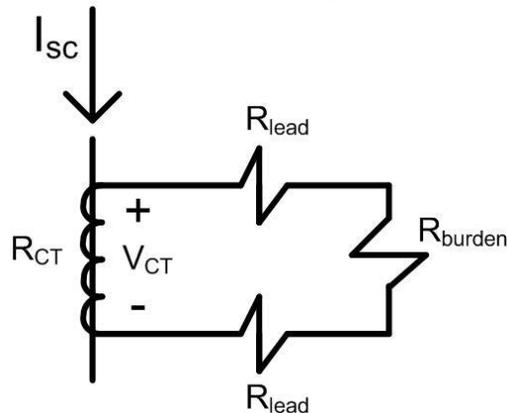
**Figure 8. CT Saturation Calculation**

Higher C class CTs can help to mitigate saturation (Figure 8).

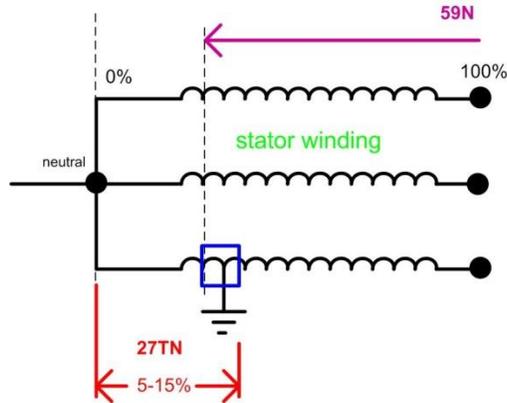
**Figure 10. 27TN and 59N Zones of Stator Ground Fault Protection**

Conventional protection (59N) cannot detect grounds in last 5 to 10 percent of stator winding. 27TN is not always reliable and may have to be blocked during specific operating conditions. If failure occurs in lower voltage portion of winding near neutral, a generator trip will not typically occur until some other relay protection detects there is a problem, (e.g., arcing becomes so widespread that other portions of winding become involved). 27TN sees stator ground faults very close to the machine neutral as shown in Figure 10.

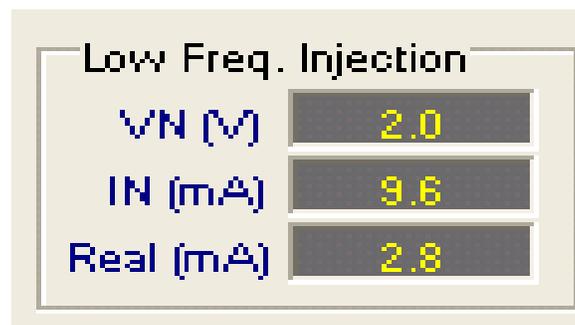
**Figure 14. Numerical Generator Relay 20 Hz Metering**

- Detect stator ground when winding insulation first starts to break down and trip unit before catastrophic damage occurs.
- Trip in order of cycles since 20 Hz signal is decoupled from 60 Hz power system.
- Detect grounds close to machine neutral or even right at neutral thus providing 100 percent coverage of stator windings.
- Detect grounds when machine is starting up or offline.
- Reliably operate with generator in various operating modes (such as a synchronous condenser) and at all levels of real and reactive power output.
- 64S can be commissioned in less than one hour assuming there are no wiring errors. See Figure 14.

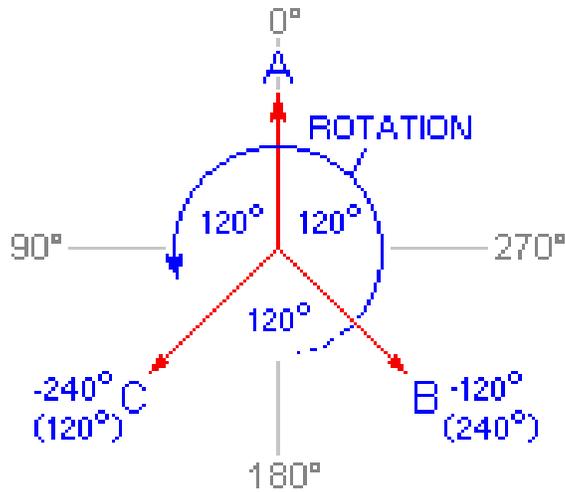
**Figure 15. ABC Phase Rotation**

Numerical protection relays require a setting to determine the correct phase rotation. Figure 15 illustrates ABC phase rotation; however, some power systems are ACB.
